Direct Tapping Comparison Study:

**Ductile Iron Pipe versus
Polyvinyl Chloride Pipe**

DIPRA conducted tests comparing the direct tapping of Ductile Iron pipe and polyvinyl chloride pipe. Cost, time, internal pressures, material strength, and other factors were also compared with respect to tapping. All tests were conducted using prescribed procedures for each material. (*Handbook of Ductile Iron Pipe* published by the Ductile Iron Pipe Research Association; the *Handbook of PVC Pipe Design and Construction* published by Uni-Bell; and *Operating Instructions for the Mueller B-100 and B-101 Drilling and Tapping Machine*.)

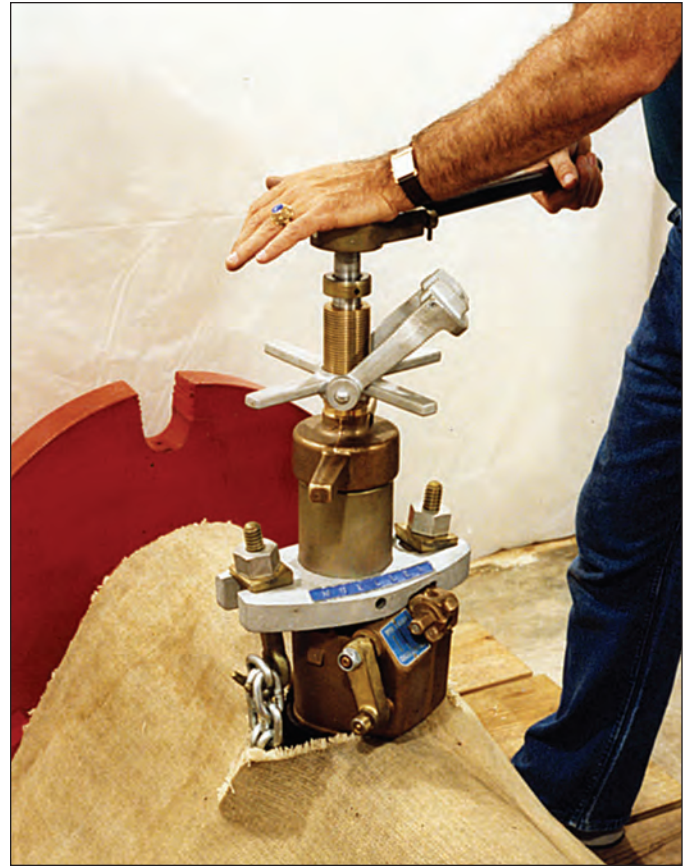
Each material was tapped according to recommendations. The average time to tap Ductile Iron pipe (left) was 16 minutes; the average time to tap pvc (right) was 25 minutes. Note that a “protective blanket with a hole in the center” was used while tapping the pvc pipe to comply with Uni-Bell’s recommended procedures.

Each material was tapped according to recommendations. A moderate, thorough pace was used by the same tapping machine operator for all tests to achieve a representative comparison. All specimens were cut in five-foot lengths, installed in the test press, and direct tapped under 60 psi internal water pressure. The tapping machine was positioned and mounted for each tap prior to the timing. The end of the tapping time was signaled after the corporation stop was inserted and torqued appropriately (30 ft-lbs for DIP and 27 ft-lbs for pvc).

Following recommended procedures, the researchers determined that tapping pvc pipe took approximately 36 percent longer than tapping Ductile Iron pipe. The increased tapping time was attributed to the fact that pvc pipe must be tapped slowly and gently to prevent the accumulation of local stresses that can cause the pipe to fail.

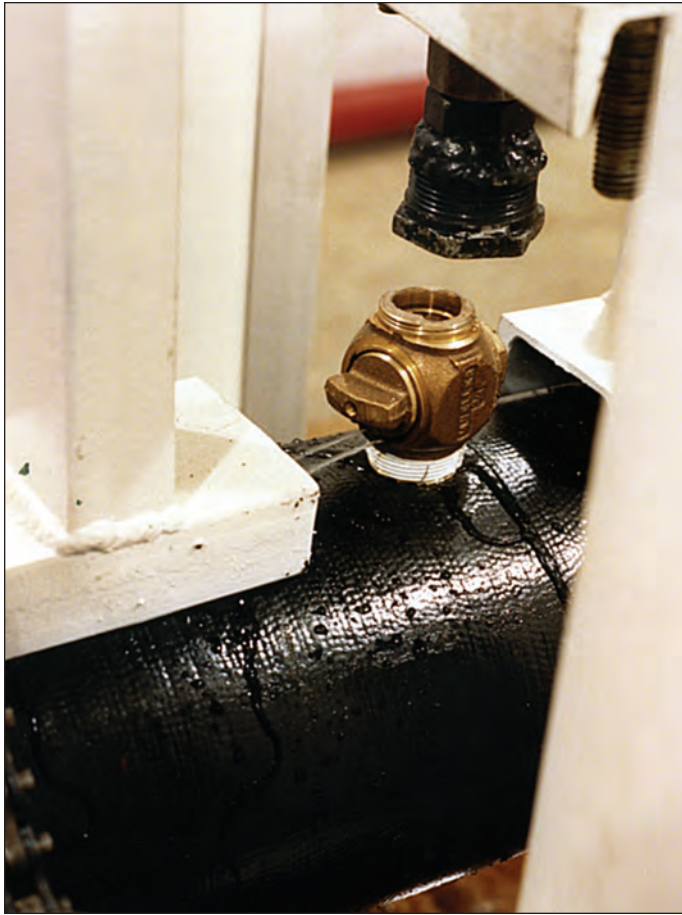
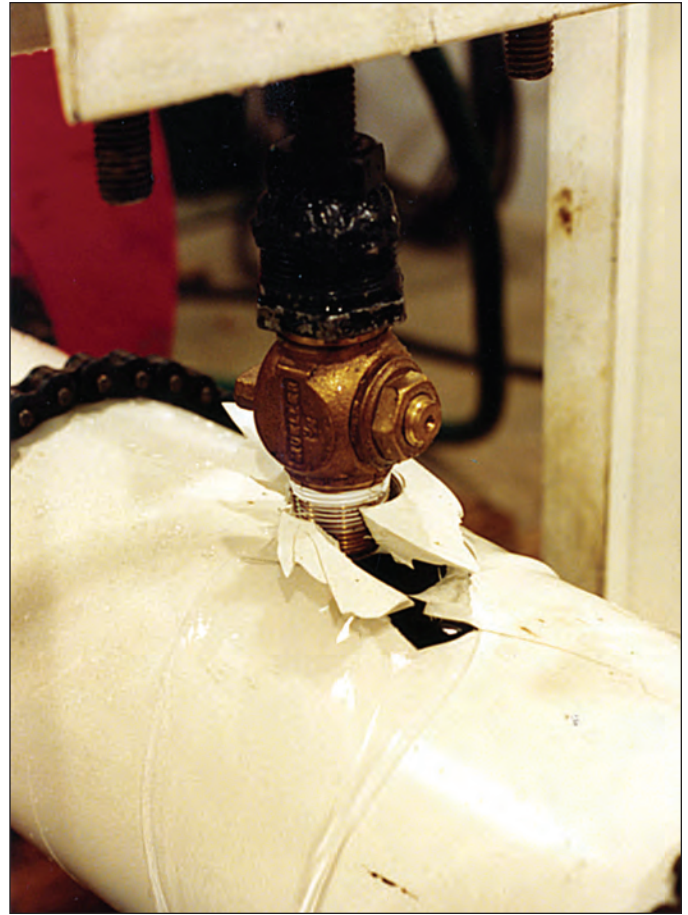
Pull-out tests were conducted to evaluate the strength and integrity of each threaded connection to the pipe material. For Ductile Iron pipe (left), the leakage occurred to the corporation stops at an average of 2,834 pounds of pulling force. In every case, the leaks were observed on the corporation stop plugs and not at the threaded connection to the pipe. Failure, which occurred at an average of 9,644.1 pounds of pulling force, occurred at the threaded connection for the service line, not the threaded connection to the pipe.

Pull-out tests on pvc pipe (right) resulted in leakage at the threaded connection to the pipe at an average of 2,800 pound of pulling force; failure at an average of 4,558 pounds. In every instance, the pulling force caused the pipe wall to break in the area of the corporation stops, resulting in the destruction of the pipe itself in the general area of the direct tap connection.

For Ductile Iron pipe, leakage occurred to the corporation stops at an average of 2,834 pounds of pulling force. In all three cases, *the leaks were observed on the 3/4-inch corporation stop plugs and not at the threaded connection to the pipe.* Actual failure occurred at an average of 9,644.1 pounds of pulling force. This failure occurred to the threaded connection for the copper service line, not the threaded connection to the pipe where leakage never occurred.

The test on pvc specimens resulted in leakage at the threaded connection to the pipe at an average of 2,800 pounds of pulling force. *In all instances, the pulling force caused the pipe wall to break in the area of the corporation stop, pulling pieces of the pipe wall out in the area of the corporation stops, resulting in destruction of the pipe itself in the general area of the direct tap connection.* These failures occurred at an average of 4,558 pounds of pulling force, less than half that required to cause failure to the corporation service line connection on the Ductile Iron pipe.

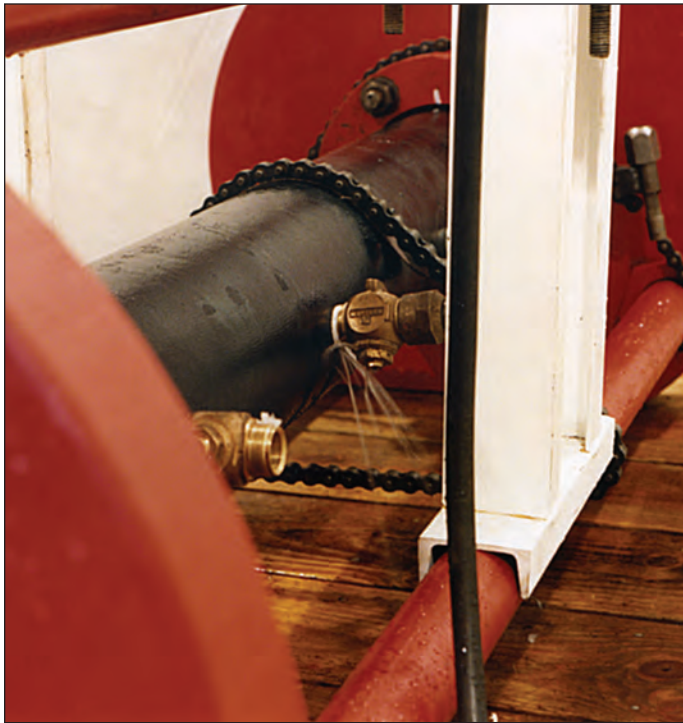
Cantilever load testing was conducted to evaluate the strength of the threaded connections of the two pipe materials. The average bending moment to cause leakage of the corporation stops in Ductile Iron pipe (left) was 2,742 in-lbs. Leakage occurred at the corporation plug on the stop and not at the threaded connection. Failure of the corporation stops averaged 4,721 in-lbs and occurred at the exposed threads just outside the connection to the pipe.

Tests on pvc specimens (right) resulted in leakage at an average of 1,990 in-lbs and, in all cases, the leak occurred at the threaded connection to the pipe. Failure occurred at an average of 3,269 in-lbs, resulting in an elongation of the threaded hole in the pipe wall. The threads in the pvc pipe wall stretched or compressed and stripped.

The average bending moment to cause leakage of the corporation stops in Ductile Iron pipe was 2,742 in-lbs. As in the pull-out tests, leakage occurred at the corporation plug on the stop and not at the threaded connection. Failure of the corporation stops averaged 4,721 in-lbs and occurred at the exposed threads just outside the connection to the pipe. Leakage never occurred at the threaded connection to the pipe.

Tests on pvc specimens resulted in leakage at an average of 1,990 in-lbs and, in all cases, the leak occurred at the threaded connection in the pipe. Failure occurred at an average of 3,269 in-lbs and resulted in an elongation of the threaded hole in the pipe wall. Closer examination revealed that the threads in the pvc pipe wall stretched or compressed and stripped.
