**DIRECT SERVICE CONNECTION
INSTALLATION COMPARISON
DUCTILE IRON PIPE VS.
POLYETHYLENE PIPE**

Direct Service Connection Installation Comparison Ductile Iron Pipe vs. Polyethylene Pipe

By Richard W. Bonds, P.E.
DIPRA Research and Technical Director

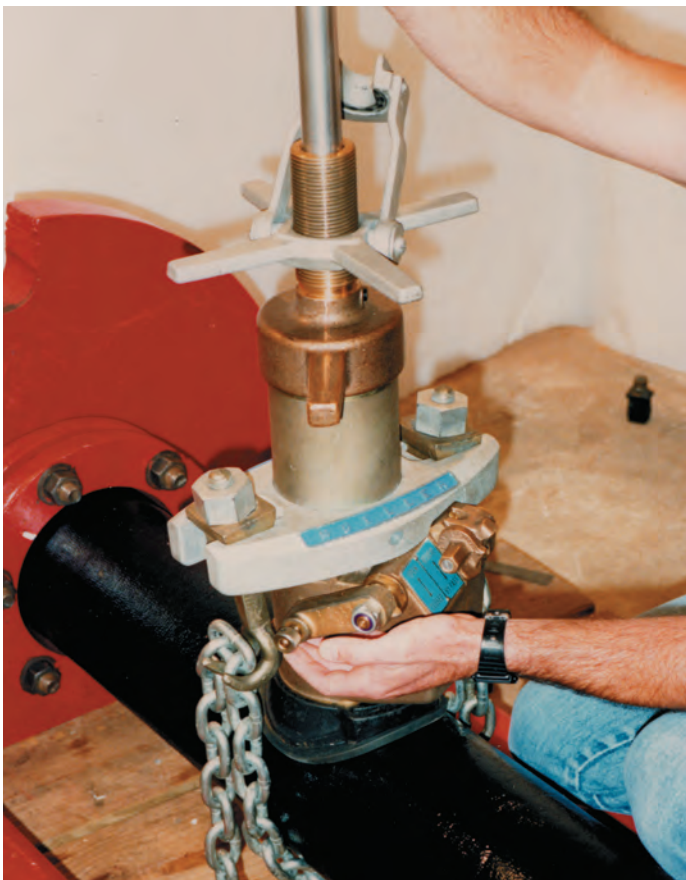
**FIGURE 1
TAPPING DUCTILE IRON PIPE**

Each material was tapped according to recommendations. The average time to tap Ductile Iron (above) was 16 minutes.

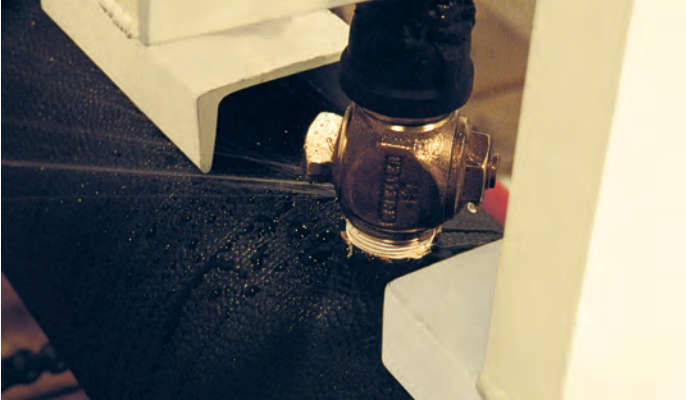
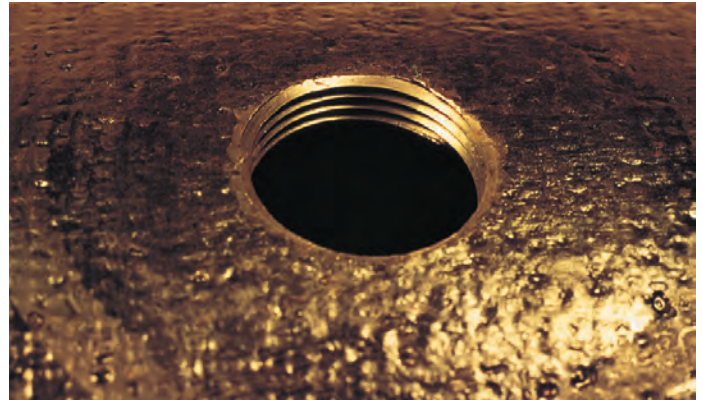
**FIGURE 3
PULL-OUT TEST
DUCTILE IRON PIPE**

Forces exerted during pull-out tests, when sufficient, resulted in failure of the corporation stop, not the Ductile Iron pipe or threads. The photo on the left shows leakage at the plug key of the corporation stop. Ultimate failure occurred to the corporation stops' threaded connection for the service line. The undamaged Ductile Iron pipe and threads are shown on the right.

An average pulling force of 3,027 pounds initiated leakage around the closed plug key of the corporation stops (no leakage was observed at the threaded connection to the pipe). Actual failure occurred at an average of 6,969 pounds of pulling force (see Table 4). These failures occurred at the threaded flare connection of the corporation stops for the copper service line, not the threaded connection to the pipe.

failures occurred at an average of 2,973 pounds of pulling force, less than half that required to cause failure to the corporation service line connection on the Ductile Iron pipe. Repair of the failed corporation stops on the Ductile Iron pipe would merely require a corporation replacement, as the Ductile Iron pipe threads were not damaged.

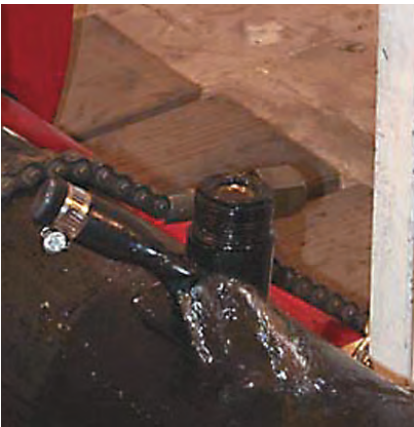
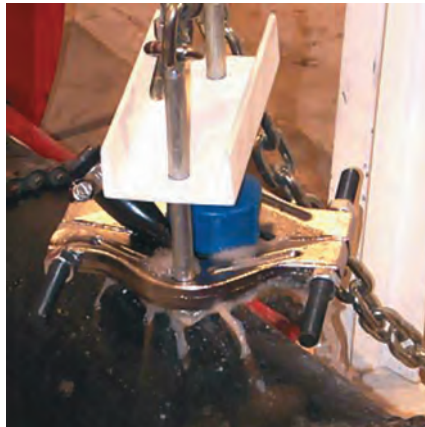
**FIGURE 4
PULL-OUT TEST
POLYETHYLENE PIPE**

The pull-out tests on the polyethylene specimen resulted in leakage at the cutter cap of the butt tap tees, rolled threads on the cutter caps, and destruction of the butt tap tees at an average of 1,065, 1,638, and 2,973 pounds of pulling force, respectively. Such failures in the field would require the pipeline to be taken out of service and a section of the polyethylene pipe cut out and replaced. Simple or quick mechanical clamps/couplings/sleeves might not work well on HDPE, and butt-fusion repair might be necessary – but not easy to accomplish – in some field conditions.

The tests on the polyethylene specimen resulted in leakage at the cutter cap of the butt tap tees, rolled threads on the cutter caps, and destruction of the butt tap tees at an average of

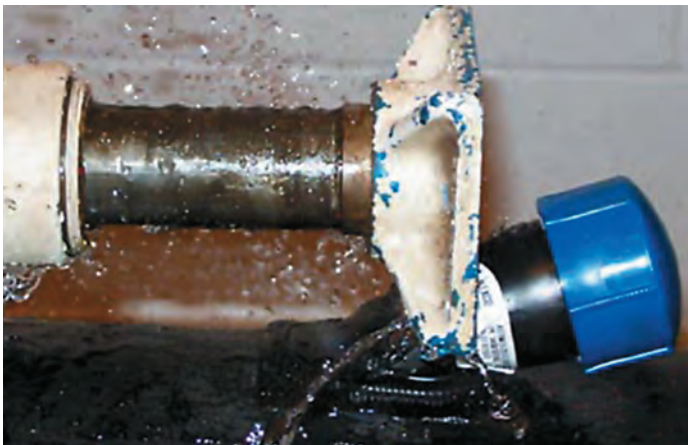
FIGURE 6
CANTILEVER LOAD TEST – POLYETHYLENE PIPE

Tests on the polyethylene pipe at left resulted in non-repairable failure and leakage of the tees at an average bending moment of 2,052 in-lbf. As in the pull-out tests, in all instances, such failures in the field would require the pipeline to be taken out of service and a section of the polyethylene pipe cut out and replaced. Simple or quick mechanical clamps/couplings/sleeves might not work well on HDPE, and butt-fusion repair might be necessary in some field conditions. That is not always easy and can prove difficult. Repair of the failed corporation stop on the Ductile Iron pipe would merely require replacement with a new corporation.

The butt tap tees subjected to the cantilever loading suffered non-repairable failure and leakage of the tees at an average bending moment of 2,052 in-lbf. (see Table 7). As in the pull-out tests, in all instances, such failures in the field would require the pipeline to be taken out of service and a section of the polyethylene pipe cut out and replaced. Repair of the failed corporation stop on the Ductile Iron pipe would merely require replacement with a new corporation.
