## Break from the ordinary.

## LP619 BREAK-OFF CHECK VALVE

## A more efficient solution for vehicle-hydrant collisions.

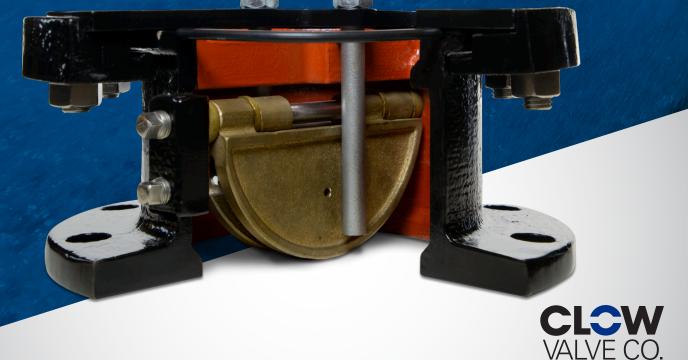
At less than six inches in height, the low-profile LP619 is designed for retrofitting existing hydrants or for new construction. The LP619 is easy to install below any C503 Wet Barrel Hydrant bolt-hole pattern. Installing the LP619

break-off check valve below a hydrant is a simple and cost-effective way to aid in water conservation, provide personal protection and reduce property losses anywhere a hydrant break is possible.
